**Flood Control Project Maintenance  
Levee Inspections**

**Fall 2013 Levee Maintenance Deficiency Summary Report**

**Reclamation District No. 2060 Hastings**

**Levee Inspection Report By Mile - Fall 2013**

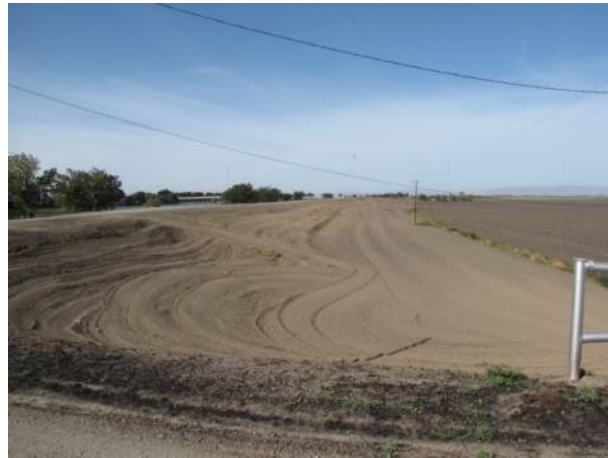
Levee Mile Report Line	4
Start Levee Mile	0.01
End Levee Mile	6.91
Location	Land Side
Category	Earthen Levee
Item	Vegetation

RD 2060 Looking downstream from levee mile 0.00 landside slope, District has removed all vegetation landward and waterward from L/M 0.00-L/M 6.94. Photo taken 10-08-2013.

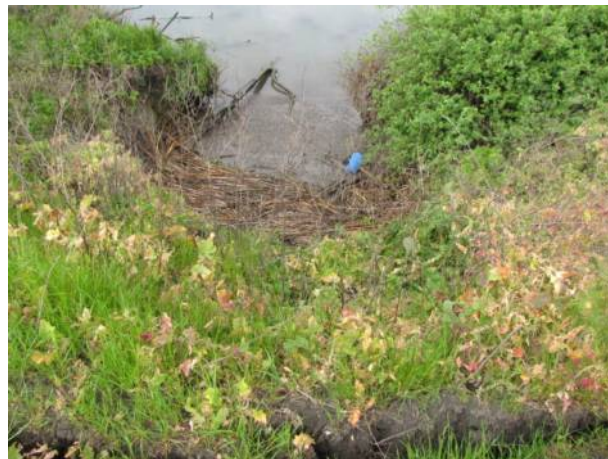
Levee Mile Report Line	7
Start Levee Mile	1.90
End Levee Mile	1.90
Location	Water Side
Category	Earthen Levee
Item	Erosion / Bank Caving

RD 2060 Levee mile 1.90 erosion site (active). Photo taken 3-28-2013.

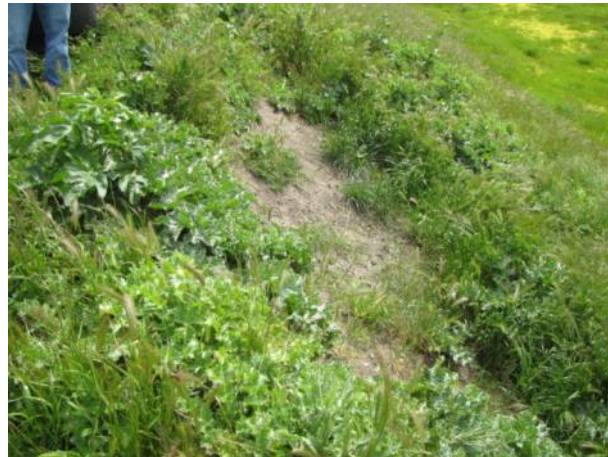
Levee Mile Report Line	9
Start Levee Mile	1.92
End Levee Mile	1.92
Location	Water Side
Category	Earthen Levee
Item	Erosion / Bank Caving

RD 2060 Erosion at levee mile 1.92 Photo taken 3-28-2013.

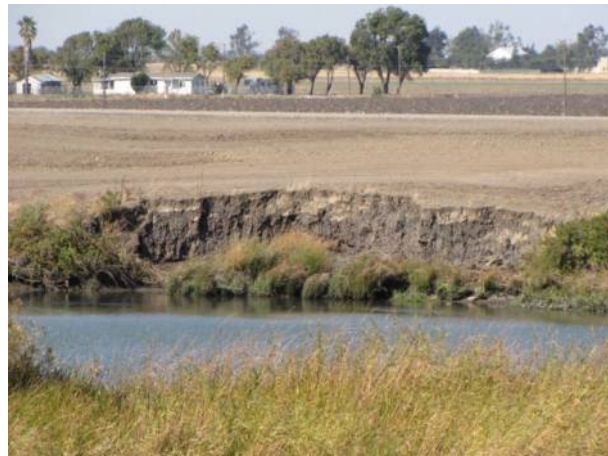
Levee Mile Report Line	10
Start Levee Mile	2.40
End Levee Mile	2.40
Location	Water Side
Category	Earthen Levee
Item	Erosion / Bank Caving

From RD 536 Looking across channel at RD 2060 Unit 1 erosion site levee mile 2.40 scour hole up to 20' deep and more than 50 feet across. Photo taken 10-08-2013.

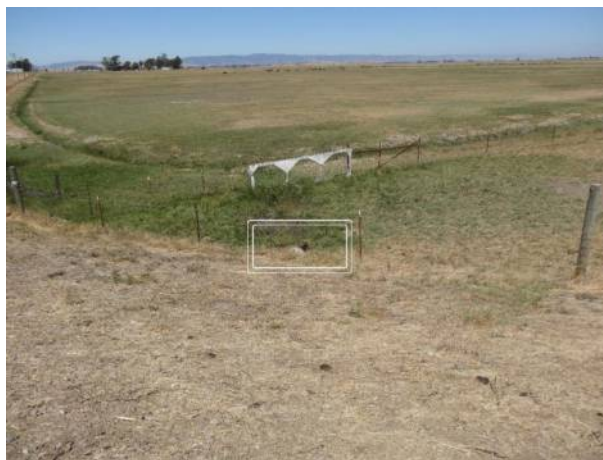
WS view: overview of CMP from levee.

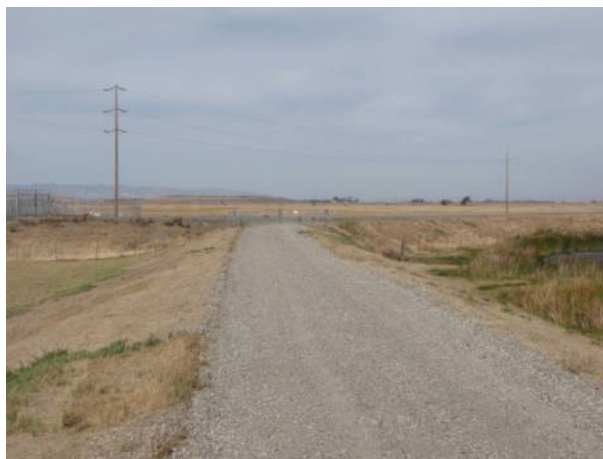
Levee Mile Report Line	2
Start Levee Mile	0.00
End Levee Mile	3.70
Location	Land Side
Category	Earthen Levee
Item	Vegetation

RD 2060 Unit 2 looking downstream from levee mile 0.00 both slopes in view. Photo taken 10-08-2013.

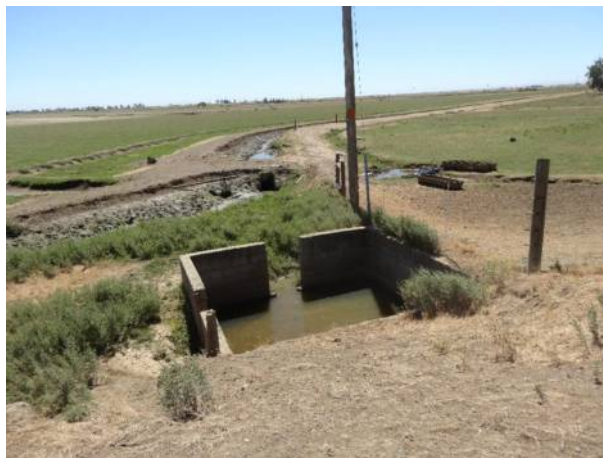
Levee Mile Report Line	8
Start Levee Mile	2.09
End Levee Mile	2.09
Location	Land Side
Category	Supplemental
Item	DWR UCIP Field Study

LS view: abandoned concrete distribution box. Not accessible due to wire fence.

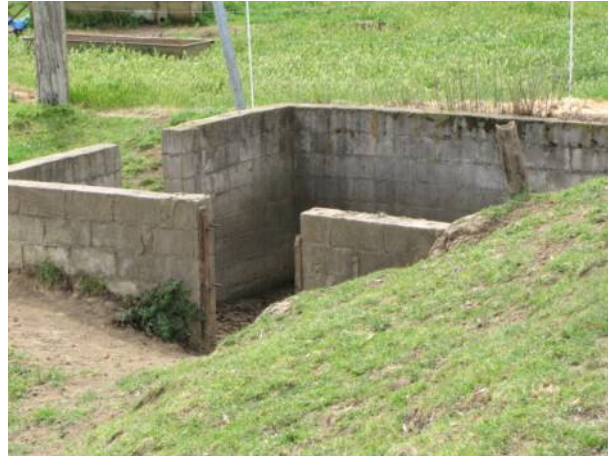
This old block structure not in use was placed within the levee section. Photo taken 3-28-2013.

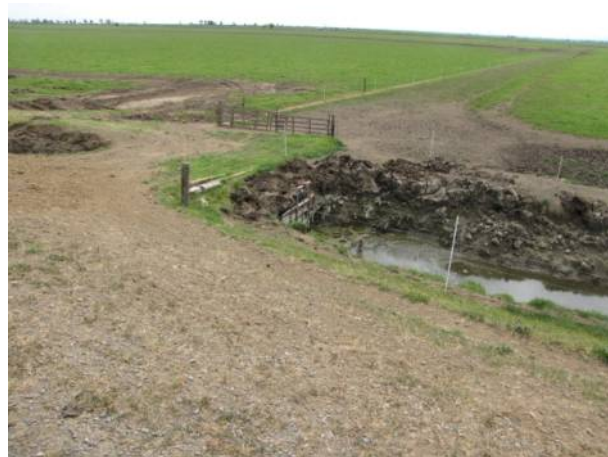
Levee Mile Report Line	12
Start Levee Mile	2.26
End Levee Mile	2.26
Location	Land Side
Category	Earthen Levee
Item	Encroachments

This ditch encroaches within the 10-foot easement. Photo taken 3-28-2013.

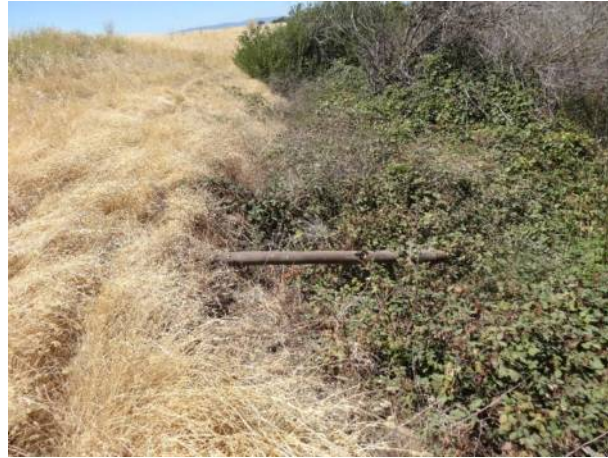
Waterside view: levee slope and only a pipe found.

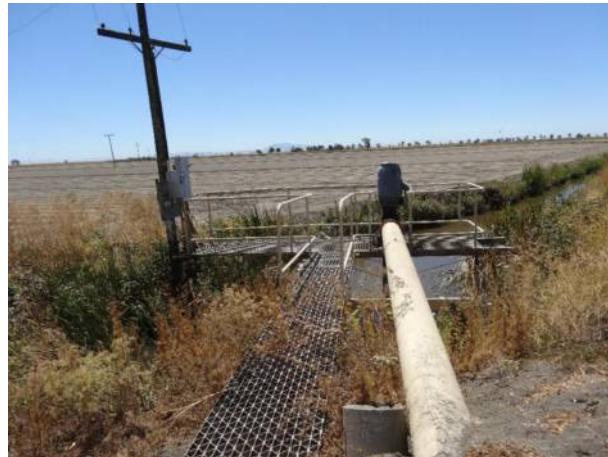
Levee Mile Report Line	2
Start Levee Mile	0.00
End Levee Mile	0.00
Location	Water Side
Category	Supplemental
Item	DWR UCIP Field Study

Landside view: pump, service pole, steel support structure, walkway, and pipe.

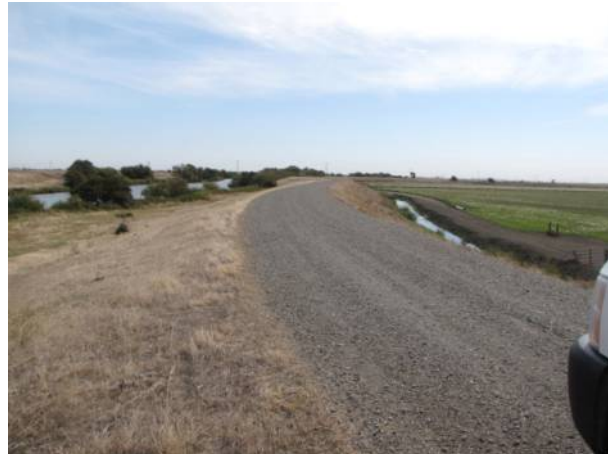
Levee Mile Report Line	3
Start Levee Mile	0.00
End Levee Mile	0.00
Location	Land Side
Category	Earthen Levee
Item	Vegetation

RD 2060 Looking downstream from the waterside shoulder. Both landside and water side slopes are in view and the growth is maintained. Photo taken 10-08-2013.

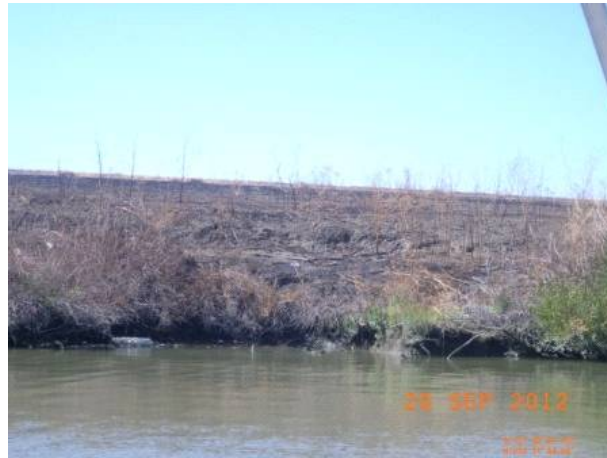
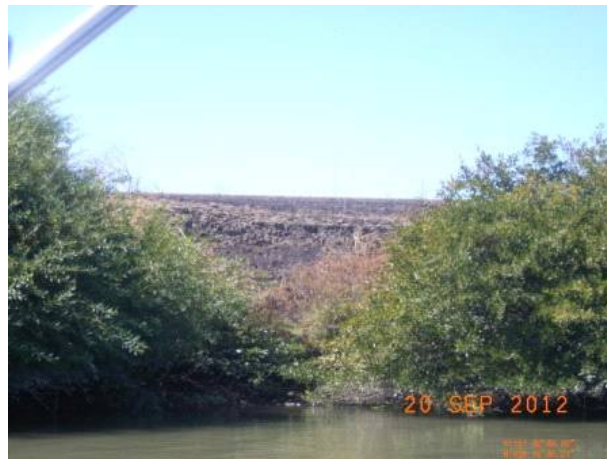
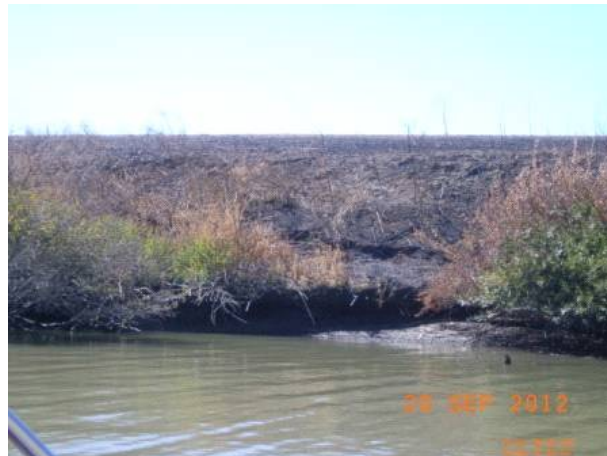
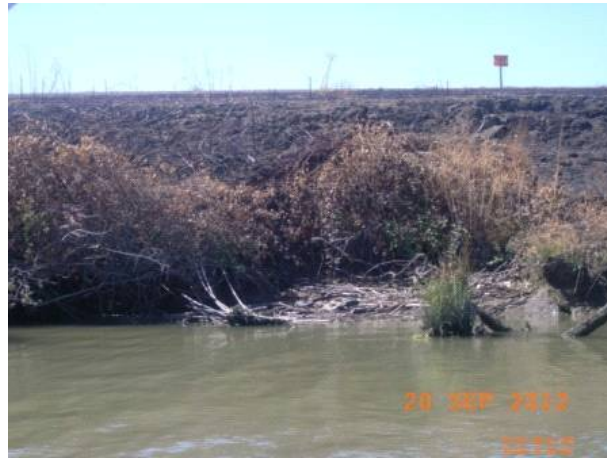
Levee Mile Report Line	11
Start Levee Mile	2.38
End Levee Mile	2.54
Location	Water Side
Category	Supplemental
Item	USACE Erosion Survey

DWR ID:										
11	2.38	2.54	Supplemental	USACE Erosion Survey	WS	M	Inspector Comments: 2008 - Small scour pockets and mid-slope wave wash. 2010 - More vegetation growth, could be fixed through maintenance. 2011 - Site extended downstream and new erosion. 2012: No observed change. [2012 Site ID: CHS_22-6_R]	38.280377 ° -121.714633 °	38.278306 ° -121.712722 °	6 Y
DWR ID:

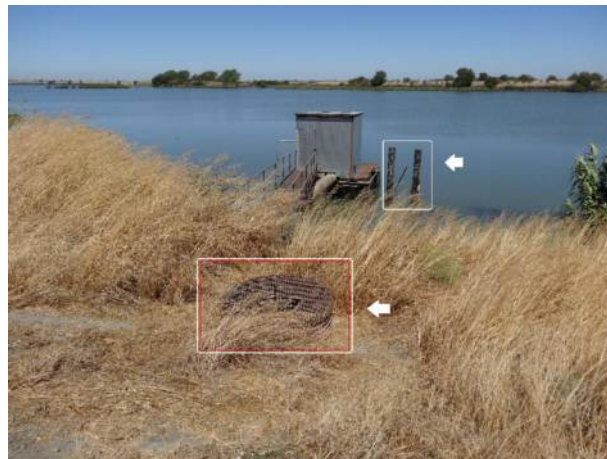
Levee Mile Report Line	17
Start Levee Mile	3.24
End Levee Mile	3.24
Location	Water Side
Category	Supplemental
Item	DWR UCIP Field Study

WS view: slide gate in CMP riser (bottom-marked) and may be abandoned pile for pump support (marked- right).
